Protect Your Soling 1 Meter

By Terry McMullen

Palm Beach Gardens Model Yacht Squadron

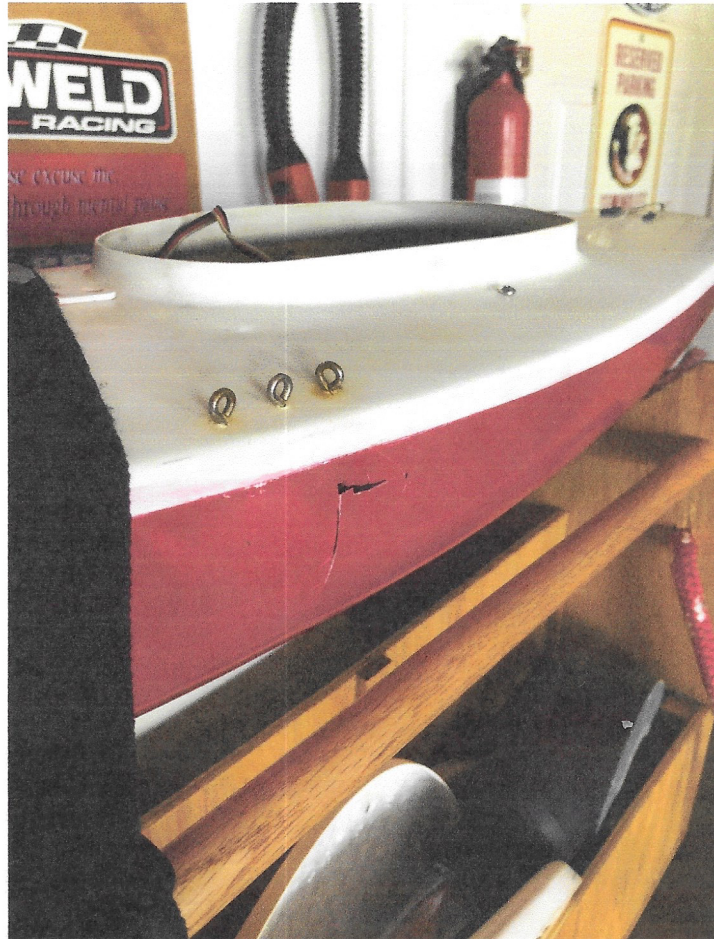
If another Soling hits your boat on the side of the bow or the side of the stern, it will most likely push your boat out of the way. If another Soling hits your boat amidships in line with the keel just forward and aft of the main stiffener, It will most likely pierce the hull. The hull areas fore and aft of the stiffener are soft and thin like eggshells. Boats built with a flush mount deck may not have this problem.

I have had three hull breaches aft of the stiffener and one forward of the stiffener all on the port side of the boat. Both areas are a nightmare to fix. The repair has to be made so the breach can be sealed up and the outside profile can be restored. This means doing an epoxy and glass cloth repair inside the boat with limited access. Every repair with heavy epoxy adds weight to the boat and makes the boat lopsided.

**Breach in Soling side wall
due to boat contact**

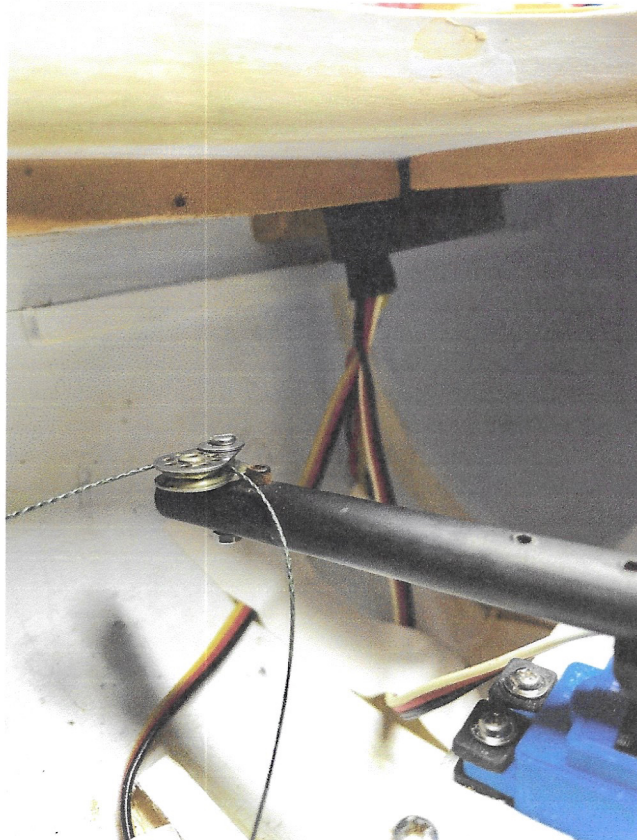
A look at the port side interior showing the fore and aft 1/4 inch square polystyrene tubing glued to the side wall

The answer to the problem was to use 1/4 inch polystyrene square tubing lengths. This clicked all the boxes for design requirements. The square tubing cross section is very stable, stiff in bending, compact without any edges to snag internal lines and virtually weightless. I cut (4) four inch long pieces of tubing. I glued the lengths horizontally to the inside wall of the boat, with one end positioned close to the stiffener, about 3/8 inch below the overlap of the deck on the hull. There should a piece of tubing fore and aft of the stiffener on both sides of the boat. I used CA (good quality super glue) or Testors orange label cement (like gel CA).

If your boat is going to be hit, it will be up high just under the deck overlap. I bought my 3DRC boat with everything inside set up by Doug Rieger except to leave the deck separate. This enabled me to have free access to make additions to the interior of the boat prior to bonding the deck to the

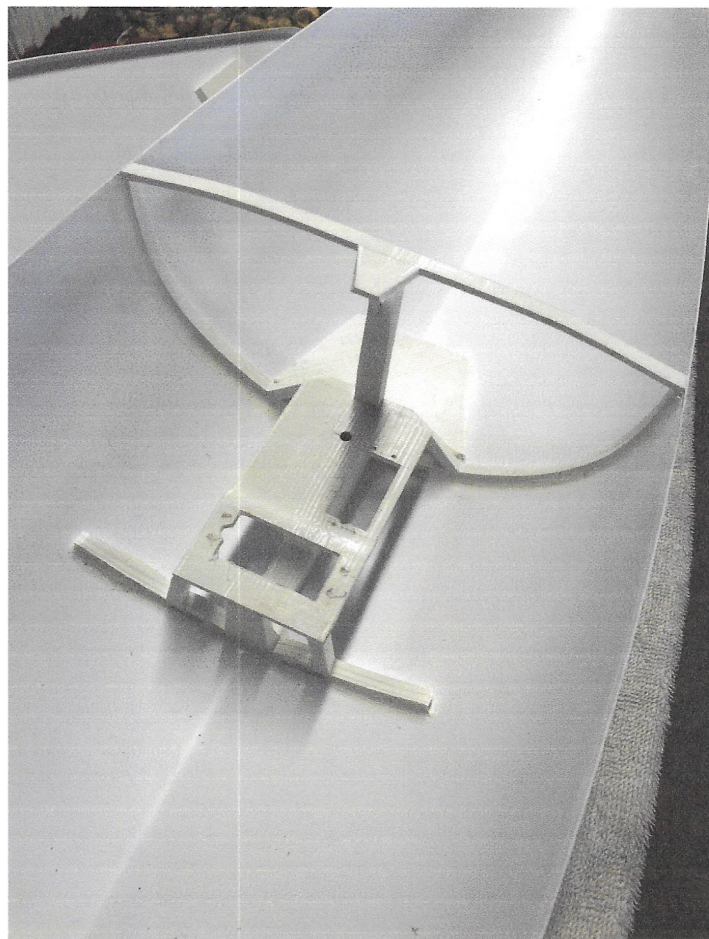
The problem was: Moving the keel in and out of the boat several times had made the stainless steel keel stud threads act like a rasp and abraded the inside of the hole in the radio board. Since the radio board was a 3D printed component, the keel threads grinding on the hole edge had made the layers of 3D printed material separate and the water was leaking from the hole between the layers of material over to the cut out for the rudder servo. The distance from the hole to the rudder servo cut out is only about a 1/4 inch. That explained why the rudder servo failed first because the leak was showering the rudder servo with water. The rest of the water leaked in during the half hour that the boat was continually doing circles in the lake.

Keel mount hole proximity to rudder servo cut out in radio board

I found a fix for the damage and prevention for the future. Remove the keel, tape over the radio board hole for the keel mount on the inside of the boat. Turn the boat over and fill the hole in the radio board from inside the keel box with liquid CA. Leave the boat overnight until the CA gets good and hard. The very thin liquid CA initially wicks into and rebonds the 3D printed layers. Then the CA cures and dries solid.

After 24 hours, carefully redrill the keel mount hole. Apply some window sealant on the base of the keel stud and insert the keel into the radio board hole. Apply some more window sealant on the first few threads of the stud that protrude through the hole on the inside of the boat. Attach the rubber seal on the stud, then the stainless steel washer and finally screw on and tighten the wing nut. Leave all this to cure overnight. Aside from checking the tightness of the wing nut on the keel stud, leave it alone. Do not remove the keel. This will prevent any leakage from the radio board hole into the boat interior.

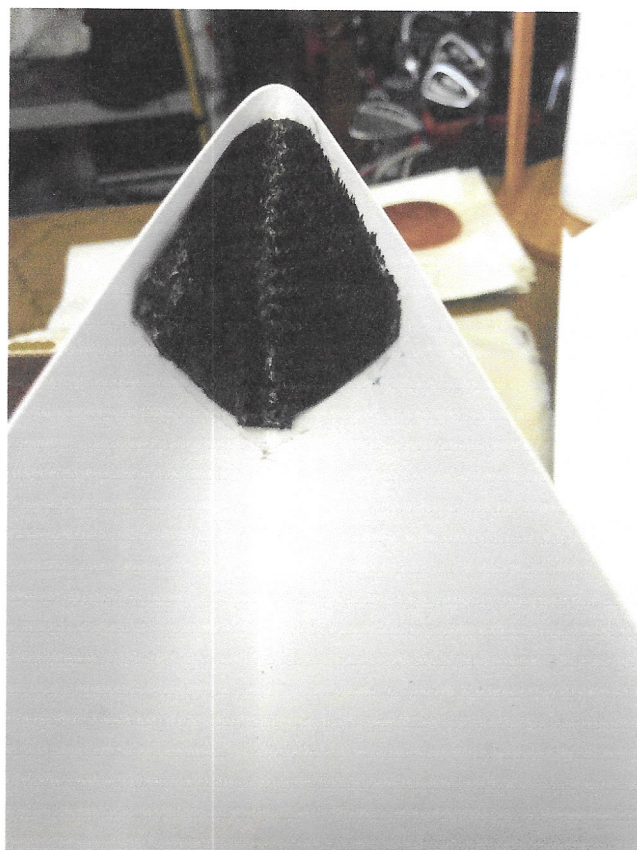
I may be the only person I know that had this problem but I protect against it anyway. The first Soling I had was made by VMP. It was not well made and was always leaking out of glue joints that opened up. One day while racing, the boat went into a crowd of boats at a far mark and I lost sight of it. When I could see it again, the boat was missing the first inch and a half of the bow...hull and deck. It was like someone had put it on a band saw and removed the first inch and a half of the boat. I don't know if I hit another boat or another boat hit me. Trying to restore the bow was a continuing nightmare. When it came time to build a new boat, I reinforced the bow. I lined the inside of the bow with glass matte and epoxy or carbon fiber matte and liquid CA before the deck was attached. The glass or carbon fiber matte has to be very flexible to sit down tight against the very 3D profile inside the bow. It is not practical to do this with an existing boat but can be made while building a new boat.

Reinforcement of the bow
